## New Insight into the Origins of the Ashdown Forest Centre Barns

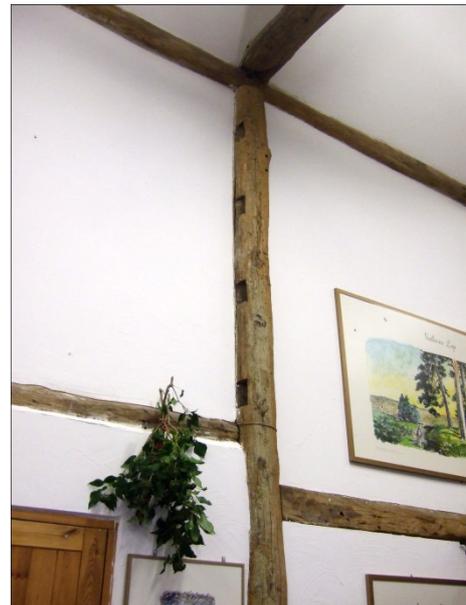
Our initial pride in showing off the barns was dampened somewhat in the Education Barn, as she was clearly underwhelmed by what she found. Mortises carved into beams failed to match up with their opposite numbers, so couldn't have held the expected but absent braces. Weathering on some of the internal posts showed them originally to have been used externally. Roof braces were too small for a structure of this size; some bays had queen posts (pairs of vertical posts linked by a horizontal and which are set on a tie beam as part of the roof truss) while others didn't, and holes in the tie braces weren't being used the way they should have been. Perhaps the feature which caused the most disdain was the use of a timber as an upright support which was cut with 'birdsmouths' - V-shaped notches sunk into an eaves beam to support rafters - something to be expected to be on a horizontal not a vertical feature.

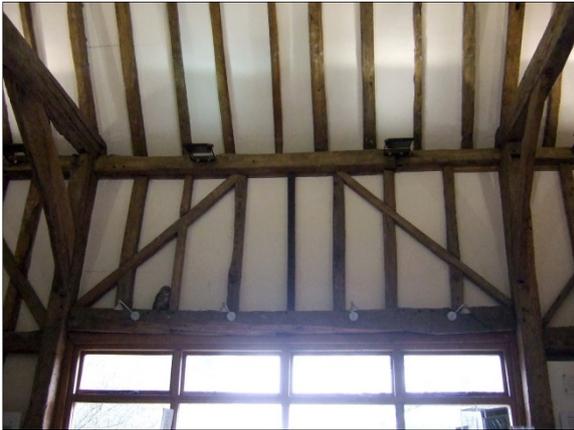
The other two barns provoked a much more positive reaction. The Information Barn is the most likely to be the Sussex barn mentioned by Barbara Willard, its proportions in keeping with Wealden style, according to Dr Hughes. It currently has four bays, but there are signs that the northern end has been tampered with at some time, so there may have been a fifth originally. This would fit the hypothesis that it had been a threshing barn. Such buildings had a pairs of doors on either side of the middle bay to allow the wind to blow the chaff away. The large window opposite the current door has a horizontal beam above, suggesting

this is where the top of the threshing doors were. Mortises set on the 'door' side of the adjacent roof beams would tend to confirm this as it was customary to place roof braces on the door-side of the posts nearest the opening. The northwest corner has a good example of a root stock upright post. Placing the tree-trunk upside-down allows the top to splay out and provide enough material for the complex jointing needed.

Other notable features in this barn are: substantial roof braces, which on the whole fit into mortises carved for them; queen posts in keeping with the rest of the barn, so probably original; and eaves plates (the long horizontal beams where walls and roof meet) which have been scarfed - had a step cut at the end of two separate timbers so that they can be linked together to run the length of a wall. There is no ridge board in the apex of the roof; instead the rafters are pegged together at the top. This, and the fact that the barn also has butt purlins (horizontal, longitudinal beams in the roof) and that these are slightly staggered to spread the load on the rafters, suggest the barn was originally erected sometime between 1650 and 1750. This barn is sizeable, probably belonging originally to a farm of at least 100 acres.

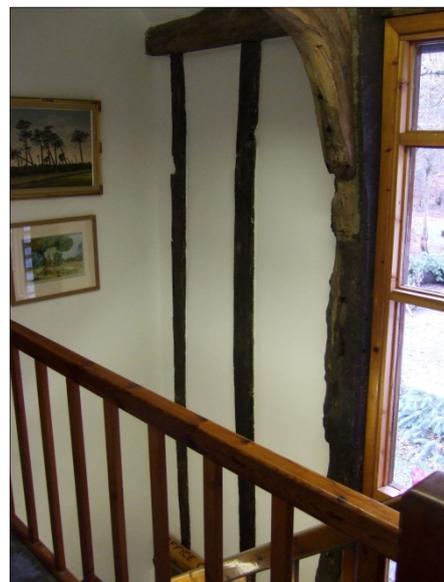
The Administration Barn, adapted considerably to turn it into office space, still shows enough original features to make it likely that this is Barbara Willard's Kentish barn. Dr Hughes identified it as of at least Eastern Wealden origin, probably from Kent, referencing the close-studding beside the stairs, which runs the entire height of the wall. In the roof space there is wind-bracing, a technique designed to stop the roof twisting out of true. This, along with other features, like the fact that the apex has been pegged, suggests that the building dates from 1650 and 1700, maybe up to 50 years older than the Information Barn.

In a number of places, original braces are still in evidence, fitting snugly into the mortises made for them over 300 years ago. However, some of these would have blocked access, or cut across an office desk in the barn's current incarnation, so in places they have been replaced by knee braces, cut from timber which has grown naturally into a right-angle. Another notable feature in this barn is the use of clasped purlins - longitudinal beams in the roof fitted under rafters and over the collar beam between them. Beams have been scarfed here too, and the ties crossing the space at eaves level have been prepared to fit solid upright timbers. Here, though, these uprights no longer exist, leaving at least one tie beam looking as if it balances rather precariously on a baulk of wood bolted to the wall. This barn has four, possibly five bays, and probably also belonged to a sizeable farm of around 100 acres.
