New Insight into the Origins of the Ashdown Forest Centre Barns

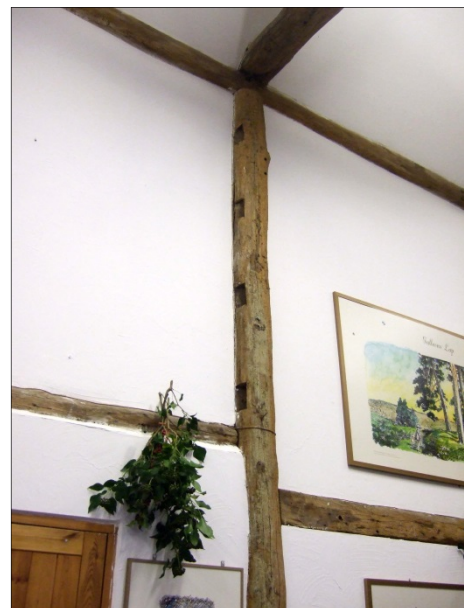
Our initial pride in showing off the barns was dampened somewhat in the Education Barn, as she was clearly underwhelmed by what she found. Mortises carved into beams failed to match up with their opposite numbers, so couldn't have held the expected but absent braces. Weathering on some of the internal posts showed them originally to have been used externally. Roof braces were too small for a structure of this size; some bays had queen posts (pairs of vertical posts linked by a horizontal and which are set on a tie beam as part of the roof truss) while others didn't, and holes in the tie braces weren't being used the way they should have been. Perhaps the feature which caused the most disdain was the use of a timber as an upright support which was cut with 'birdsmouths' - V-shaped notches sunk into an eaves beam to support rafters - something to be expected to be on a horizontal not a vertical feature.

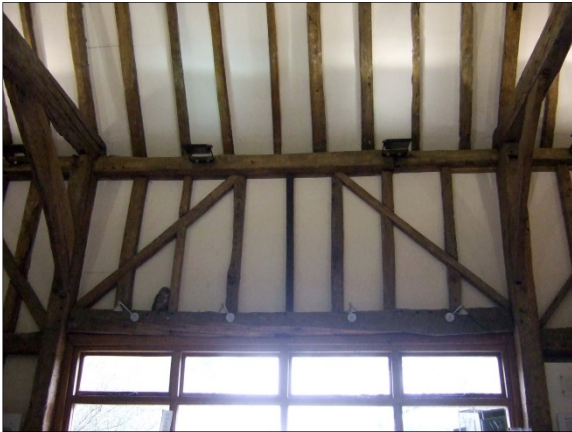
The other two barns provoked a much more positive reaction. The Information Barn is the most likely to be the Sussex barn mentioned by Barbara Willard, its proportions in keeping with Wealden style, according to Dr Hughes. It currently has four bays, but there are signs that the northern end has been tampered with at some time, so there may have been a fifth originally. This would fit the hypothesis that it had been a threshing barn. Such buildings had a pairs of doors on either side of the middle bay to allow the wind to blow the chaff away. The large window opposite the current door has a horizontal beam above, suggesting

this is where the top of the threshing doors were. Mortises set on the 'door' side of the adjacent roof beams would tend to confirm this as it was customary to place roof braces on the door-side of the posts nearest the opening. The northwest corner has a good example of a root stock upright post. Placing the tree-trunk upside-down allows the top to splay out and provide enough material for the complex jointing needed.

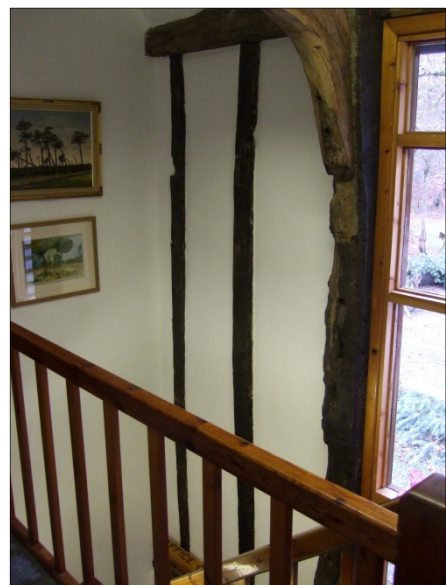
The Administration Barn, adapted considerably to turn it into office space, still shows enough original features to make it likely that this is Barbara Willard's Kentish barn. Dr Hughes identified it as of at least Eastern Wealden origin, probably from Kent, referencing the close-studding beside the stairs, which runs the entire height of the wall. In the roof space there is wind-bracing, a technique designed to stop the roof twisting out of true. This, along with other features, like the fact that the apex has been pegged, suggests that the building dates from 1650 and 1700, maybe up to 50 years older than the Information Barn.

In a number of places, original braces are still in evidence, fitting snugly into the mortises made for them over 300 years ago. However, some of these would have blocked access, or cut across an office desk in the barn's current incarnation, so in places they have been replaced by knee braces, cut from timber which has grown naturally into a right-angle. Another notable feature in this barn is the use of clasped purlins - longitudinal beams in the roof fitted under rafters and over the collar beam between them. Beams have been scarfed here too, and the ties crossing the space at eaves level have been prepared to fit solid upright timbers. Here, though, these uprights no longer exist, leaving at least one tie beam looking as if it balances rather precariously on a baulk of wood bolted to the wall. This barn has four, possibly five bays, and probably also belonged to a sizeable farm of around 100 acres.
